**DELAWARE RIVER BASIN  
LEAVITT BRANCH, BRODHEAD CREEK  
MONROE COUNTY  
PENNSYLVANIA  
NDS ID PA. 00814  
DER ID 45-250**

**SOIL CONSERVATION SERVICE DAM PA-463  
(LEAVITT BRANCH DAM)**

**PHASE I INSPECTION REPORT  
NATIONAL DAM INSPECTION PROGRAM**

**MARCH 1979**

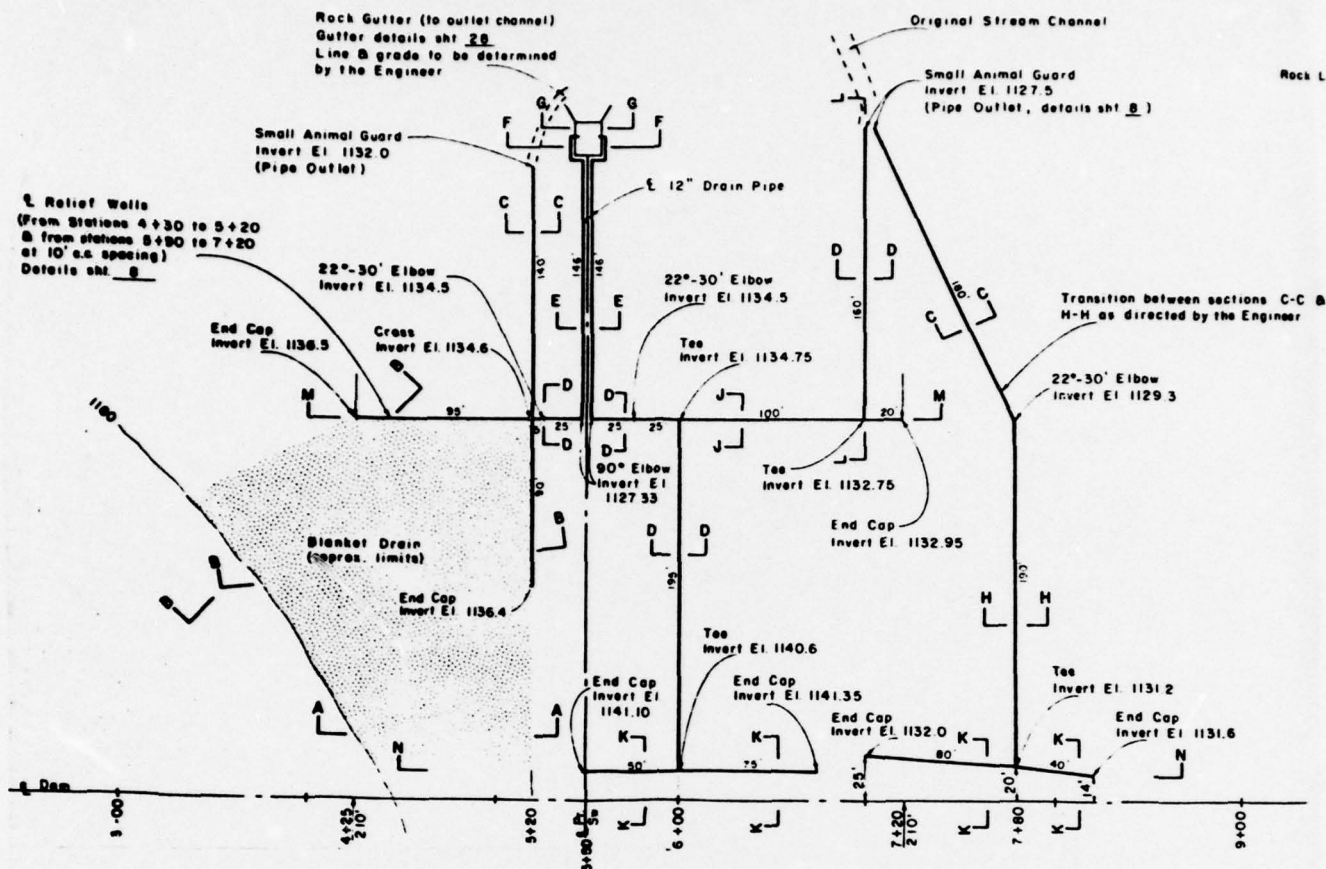
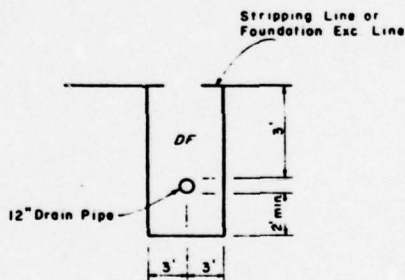
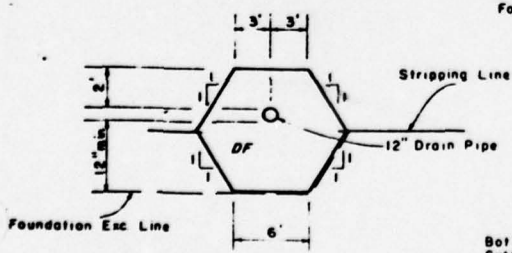
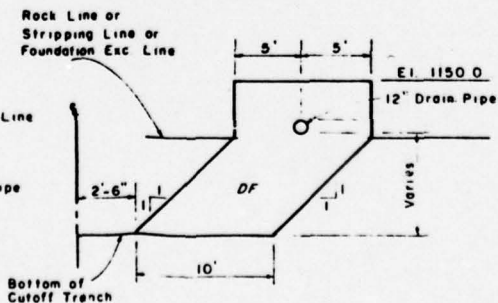
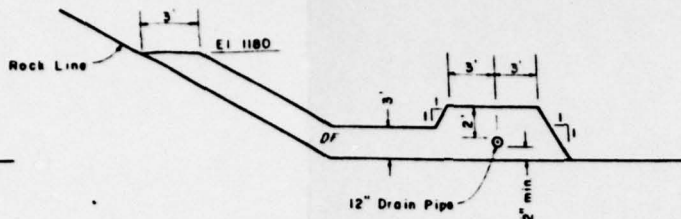
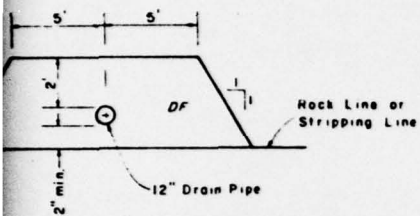
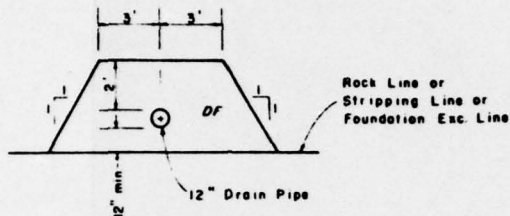
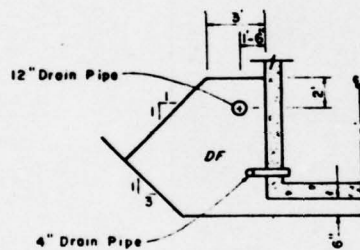
2  
PLATE 5

→ The dam contains an unusual internal drainage system (see Plates 3 and 5). Drain fill material was placed on the downstream slope of the cutoff trench excavation. In addition, a trench drain was placed about two-thirds of the distance from the centerline to the downstream toe and a blanket drain is under a portion of the dam. Seepage collected in the drains outlets in the impact basin at the downstream toe or through one of the three pipes discharging at the downstream toe.

As a result of a site visit on 16 April 1974 by SCS personnel from the State and regional offices, the original internal drainage design was questioned and a reevaluation was performed. Concern was expressed by the inspector as to whether fill material would pipe into the drain fill. Therefore, samples of the fill and drain material were taken from the embankment to determine if piping had actually taken place. As a result of this reevaluation, the internal drainage systems were redesigned to the configurations shown on Plates 5 and 5a, Appendix E.
